Warning and Recall Regarding Our Tone Touch 03 and Tone Touch 04 Products

Technical Modification of the Tone Touch 03 and 04

Due to Risk of Electric Shock to the Operator

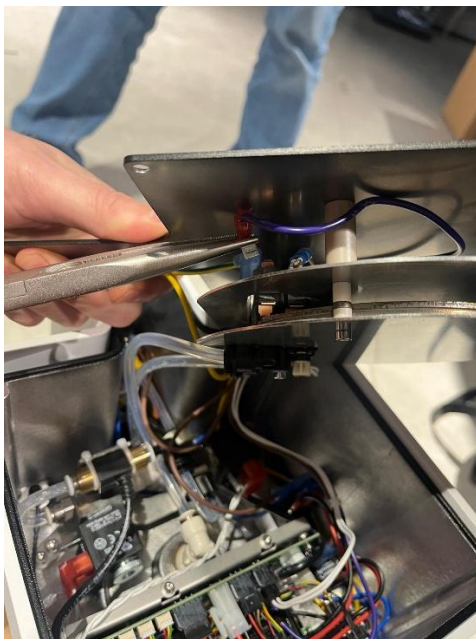
- 1) Unplug the purple connector from the FTH (heating element)

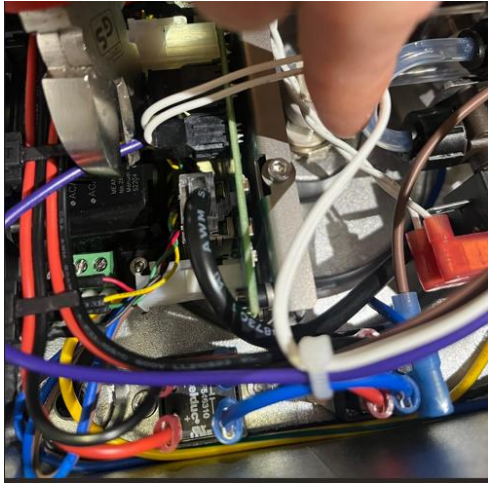
- 2) Next, use a side-cutting plier to cut the purple cable at the connector on the PCB side. The cable can then be completely removed from the machine.

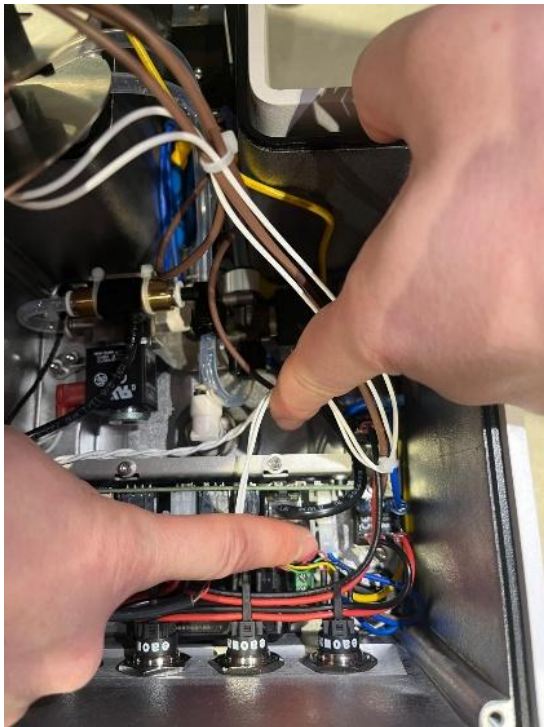
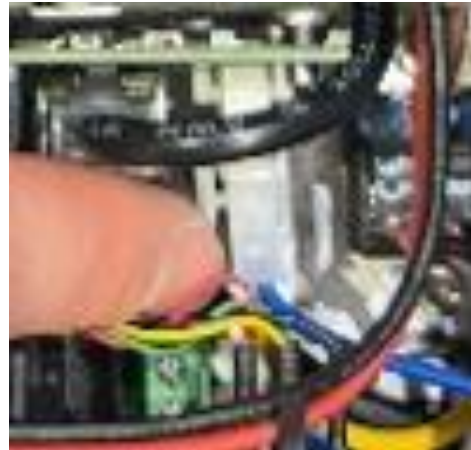
- 3) Next, disconnect the 230-volt plug from the PCB board.

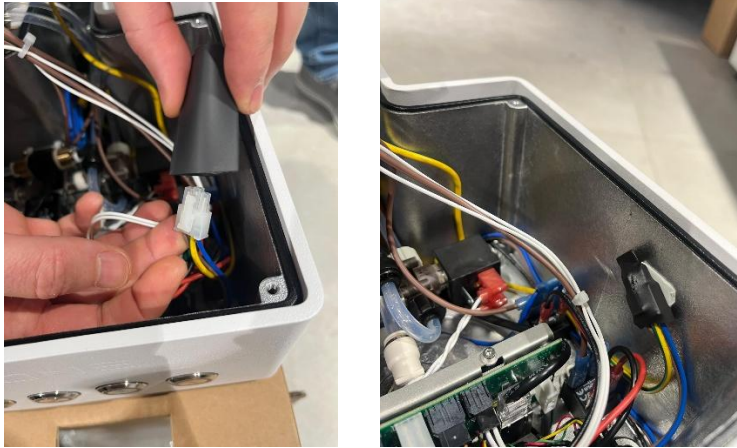
- 4) Next, insulate the 230-volt plug using the heat-shrink tubing included in the upgrade kit. This is best done by heating it (with a lighter or heat gun), but you can also use the cable ties included in the kit.

- 5) Then secure the insulated connector to the housing using the adhesive pad provided (!! Do not leave the cable loose inside the machine !!)
- 6) Afterward, close the machine again and install it as appropriate.

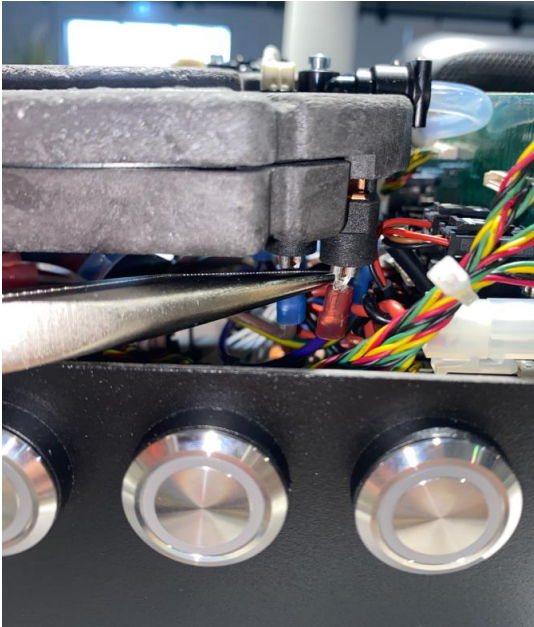
- 1) Unplug the purple connector from both FTHs (heating elements)

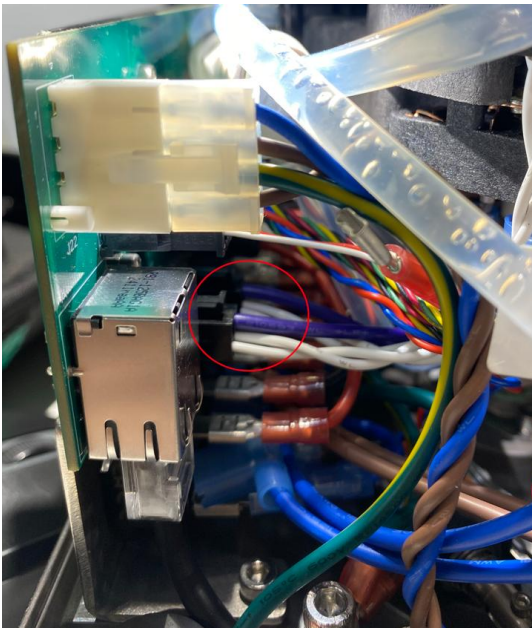
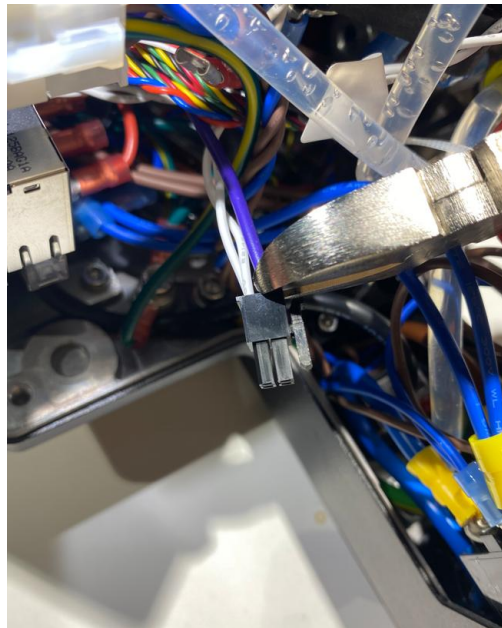
- 2) Next, use side-cutting pliers to cut the purple cables at the connector on the PCB side. The cable can then be completely removed from the machine. This must be done for both E Fast cables!

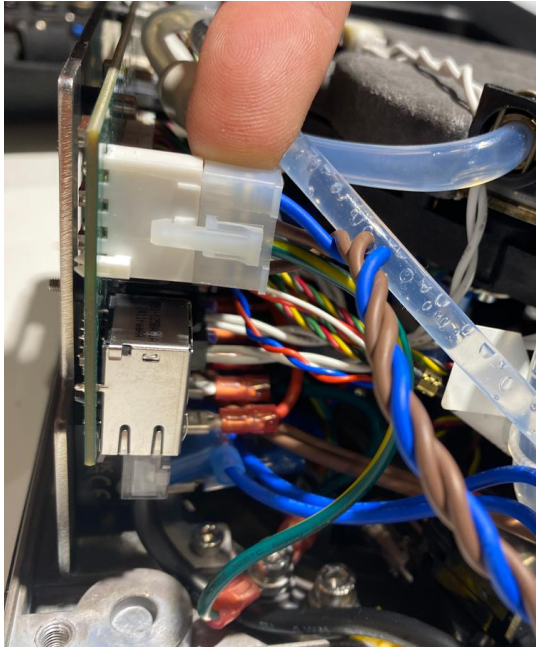
- 3) Next, disconnect the 230-volt plug from the PCB board

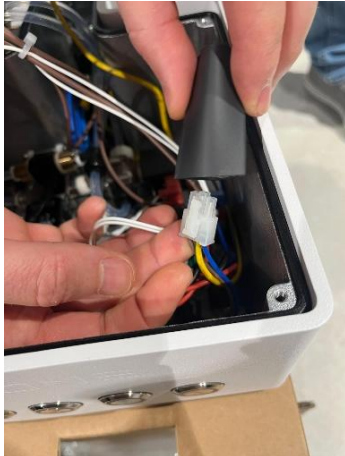
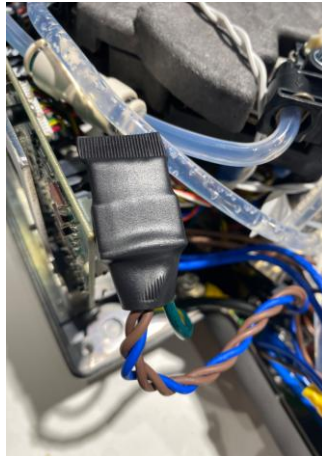
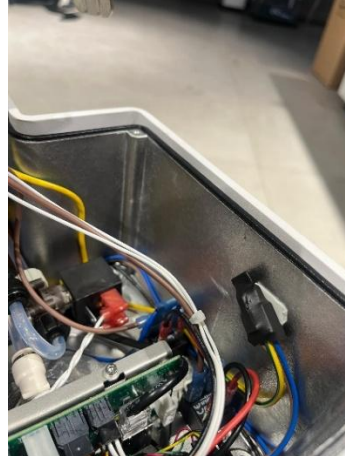
- 4) Next, insulate the 230-volt plug using the heat-shrink tubing included in the upgrade kit. This is best done by heating it (using a lighter or heat gun), but you can also use the cable ties included in the kit..

- 5) Then secure the insulated connector to the housing using the adhesive pad provided (!! Do not leave the cable loose inside the machine!!)
- 6) After this, the machine must be resealed and installed properly.
